IMPECABL: Improving environmental control and battery life through integrated monitoring systems

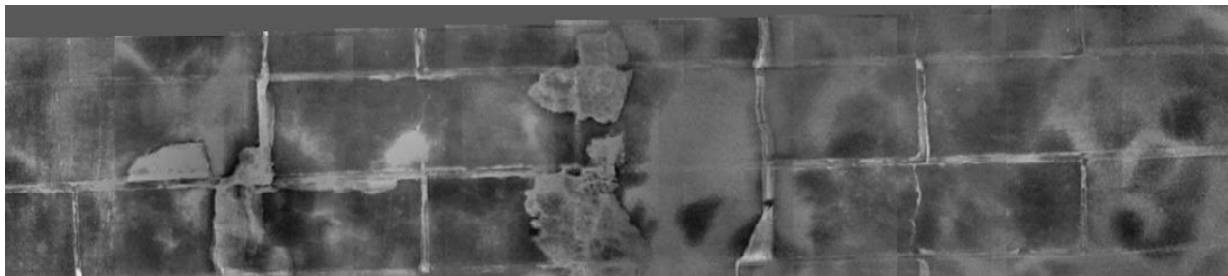
Fig. 2 Picture of a wall part generated by the processing software

Due to the development of several image processing packages, the coke oven wall inspection image processing software is able to generate a picture of each wall. Figure 2 is an example of the result given by the software. The generated picture clearly shows that it is possible to identify the damage location and the extent of any damage. Cracks and wear are easy to identify by human eye. A complete wall picture shows the location of the different defects. The duration of a single wall data treatment is around 30 minutes. The software calculation time was optimised within the project.

Due to the development of several image processing packages, the coke oven wall inspection image processing software was able to generate a picture of each wall. Figure 2 is an example of the result

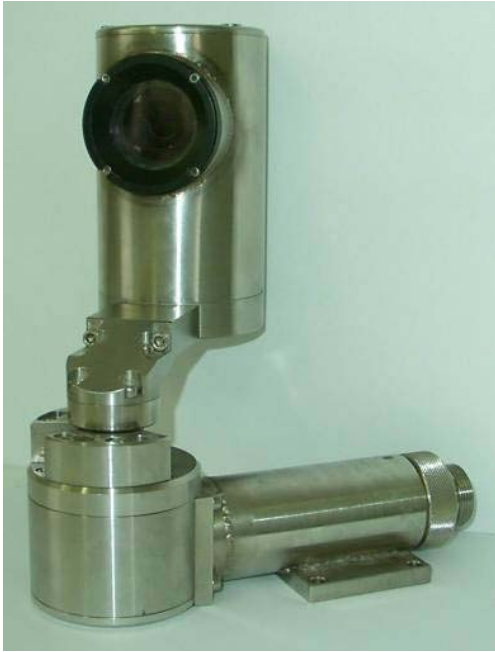
During the preliminary tests by CPM for the chamber monitoring system, a black and white SONY XC73 camera, which was more sensitive than a colour camera, was set up with a motor allowing a 180° rotation. This camera offered the possibility of external synchronisation, but it had no automatic shutter. Consequently, the exposure must be controlled by an external trigger. Seen in Fig. 4, this camera head was also equipped with a temperature sensor to prevent any overheating. This temperature was permanently displayed on the control unit of the device.

Fig. 4 First sensor design

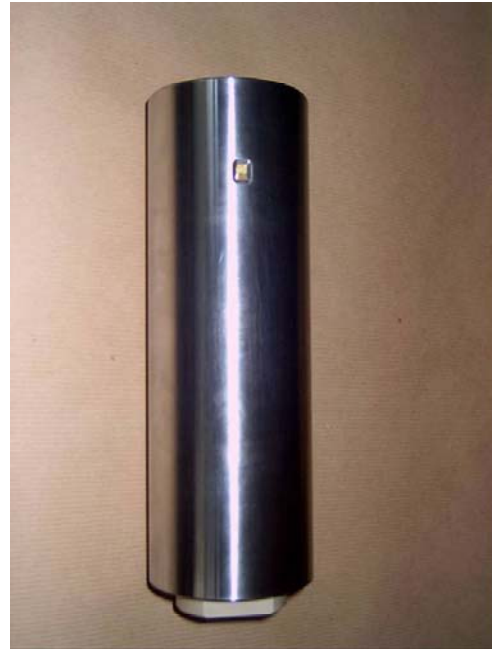
For all these reasons, a new objective lens with a wider field of view and a smaller lens window was specially designed and built. The new objective lens offered a wider field of view of 116° in the vertical direction instead of 72° and a very small window (see Fig. 5). In addition, the camera head included a new WATEC 525EX camera with an automatic shutter. The shape of the camera head also made insulation easier.

Fig. 5 New camera head design

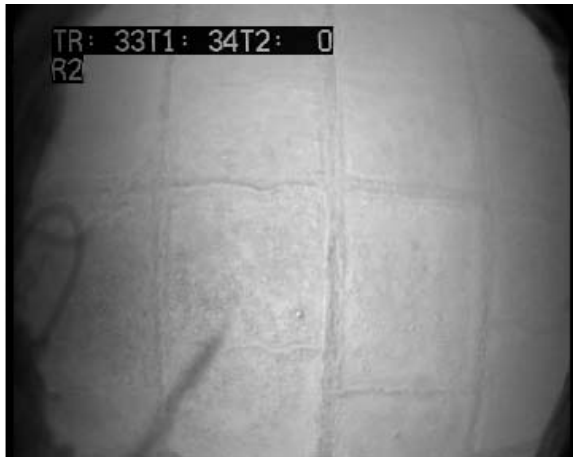
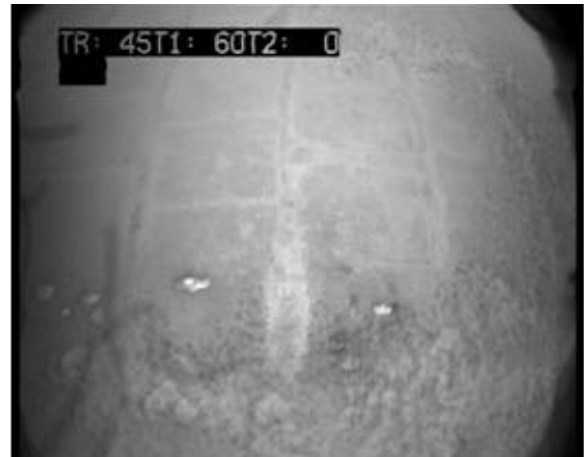
Probably, the camera air cooling will be more efficient with the installation of the inspection device on the pusher ram. During the preliminary trials, the air came from a pipe located on the oven, which already heated the cooling air. The different trials showed the good performance of the new camera head in terms of use, wideness of the field of view and image quality. The final camera head fulfilled CPM requirements.

Fig. 6 Brick joints clearly visible

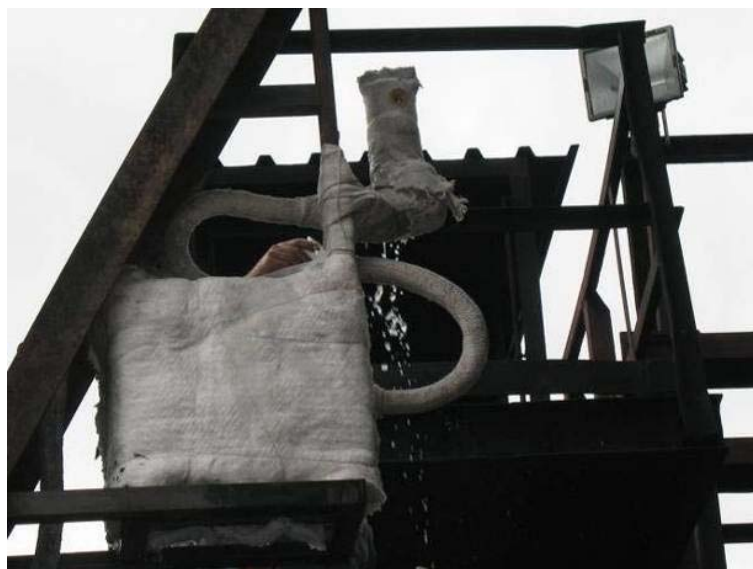
The chamber wall observation device is not water-cooled. Only air coming from the decarbonising air pipe is used to avoid overheating of the whole system. Part of the decarbonising air is used to cool the coaxial cable, the electronic components of the multiplexing box, as well as the camera. Air is also ejected just in front of the objective in order to avoid dust deposits on the lens. Before use, this air is de-dusted and de-oiled in an additional air treatment system. In addition, the cables between the decarbonising air pipe, the multiplexing box and the camera head were protected by stainless steel sheets insulated with different layers of ceramic fibre. The camera head and the camera are also protected by ceramic fibre (see Fig. 11).

Fig. 11 Insulated camera, electronics and cables

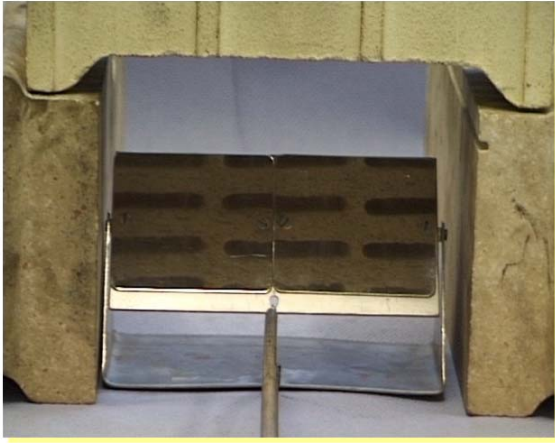
Fig. 15 Camcorder view of the swivelling mirror of Prototype 1 inspection system at a cold test checker brick

Photographs from laboratory testing are shown in Figs. 15 and 16, with light effects from temperature radiation in a hot regenerator simulated by the incidence of daylight (in Fig. 16). In laboratory trials with a cold test checker brick, single brightened slots of the regenerator brickwork could be made visible with the Prototype 1 inspection system. However, later plant trials in WP 6 showed that the optical characteristics of the welding mirror were only mediocre under hot regenerator conditions. Additionally, some other weak points were identified for the Prototype 1 inspection system in the plant trials (see Task 6.5).

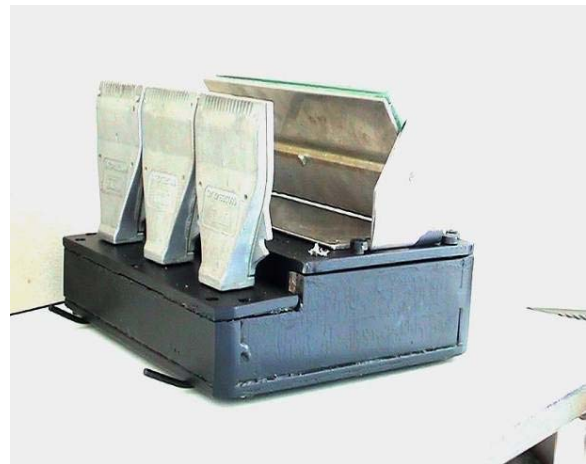
Cleaning equipment with three air nozzles was integrated into an optimised Prototype 2 inspection system (developed in Task 3.3) to remove dust and other abrasive deposits from the regenerator brickwork by air blowing air. Photographs of the combined inspection/cleaning system are shown in Fig. 17.

Fig. 17 Combined inspection/cleaning system

The combined inspection/cleaning system was tested in plant trials (see WP 6). Large quantities of dust and other deposits could be blown away from the brickwork in the lower sections of the regenerator with the integrated cleaning equipment. Whether brickwork cleaning also reached upper parts of the regenerator could not be monitored with the inspection system. Additional illumination was applied in the Prototype 2 inspection system to make details of brickwork damage and cleaning effects visible. With additional illumination, however, swirling dust during cleaning caused too much backscattering of

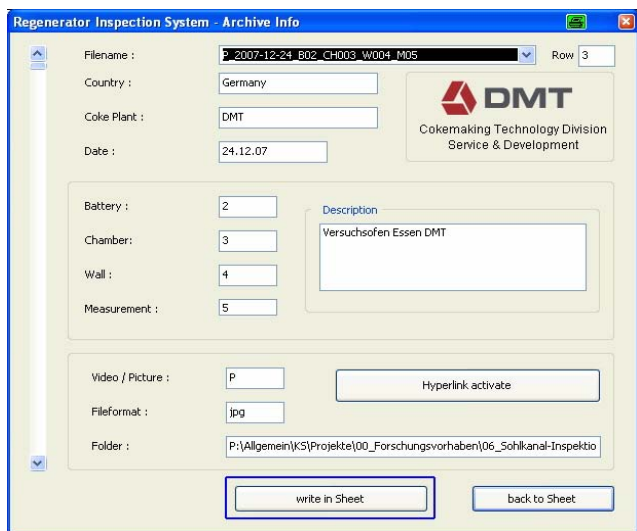
For the organisation and archiving of the data files obtained from video recording, basic software from ULEAD Systems was used by DMT to develop and optimise RISA (Regenerator Inspection System Archive). Functions for data input and search functions were implemented additionally into RISA, using EXCEL. The input data mask and a screenshot of RISA are shown in Figs. 21 and 22.

Fig. 21 Input data mask of RISA

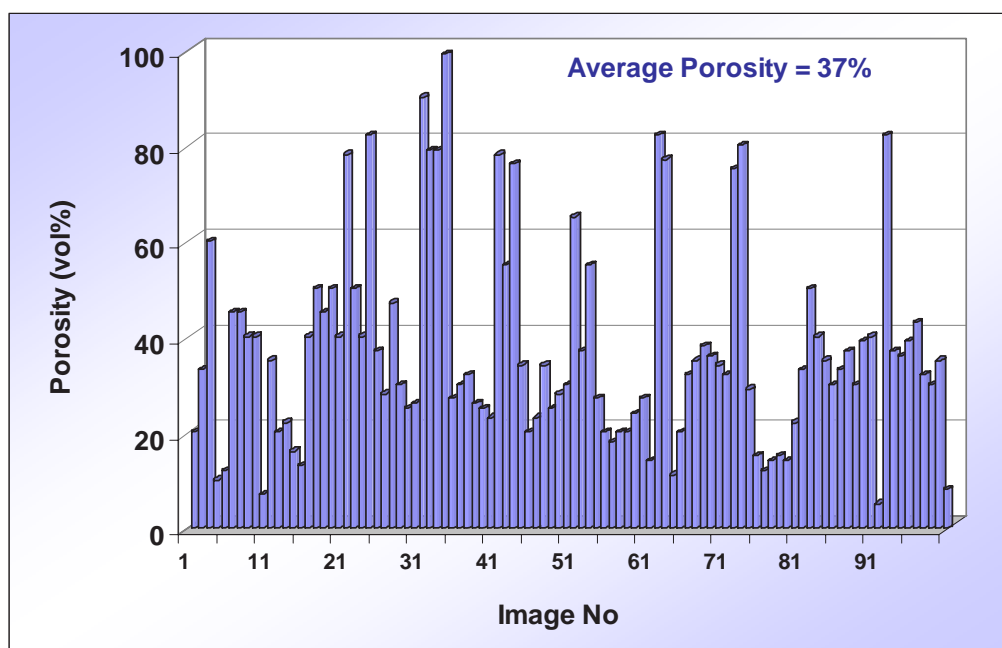
Mosaic – 10 x10 images

Binary Mosaic

Fig. 25 Porosity measurement by image analysis

Using optical microscopy, a fully automatic image analysis method for the determination of coke porosity was developed, based on a versatile image-processing system. Images of an entire polished sample of carbon deposits can be captured automatically by the system for further processing and analysis. The developed programme is capable of generating a mosaic of up to 30 x 30 images, enabling porosity of the entire mosaic to be determined. This has the potential to estimate individual pore sizes and pore-size distributions. The main feature of the method is that adjacent frames are

captured and the material inside each frame is quantitatively assessed, whilst that cut by the frame edges is saved and measured before the results are merged to produce data representative of the whole of the mosaic. Figure 25 illustrates the image processing sequence of this programme for a mosaic sampled from a carbon deposit. For this sample, U, the porosity was assessed as 37% by volume. Another advantage of this method is that small pores can be measured readily by processing single images, whilst macropores, which may not be completely shown in single images, can be analysed by combining images to generate suitable mosaics.

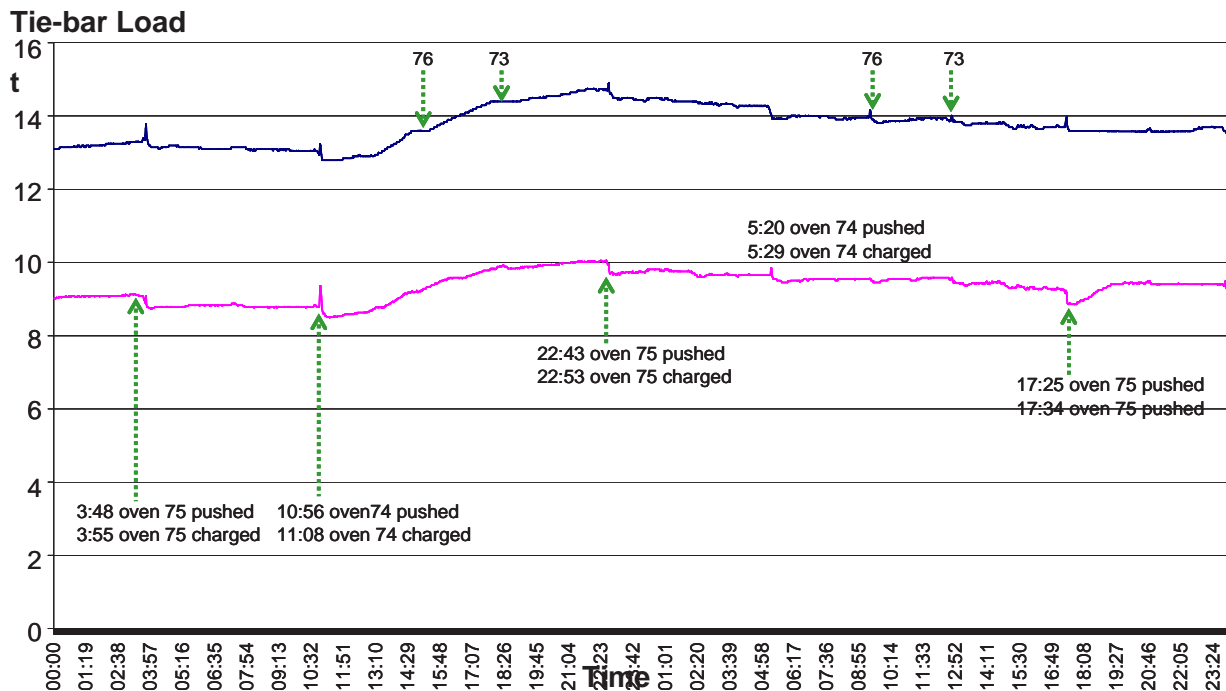
Fig. 29 Changes in tie-bar loads on Buckstay 75 with charging and pushing of adjacent ovens

The new design of load cell was installed on the tie-bars of one buckstay on a taller battery. After successful operation for several months, a further six sensors were fitted at intervals along the length of two batteries. Data were collected on a logger and could be sent via an Ethernet connection or hard-wired to the plant control system. Changes in the loads on sensors were monitored, and these could be identified with specific plant events. Figure 29 demonstrates that observed load variations were not limited to actions in the ovens adjacent to the monitored buckstays, as even charging and pushing of ovens 73 and 76 were identifiable in data collected from load cells on Buckstay 75. In Fig. 30, increased loads in the blue line on 03. May and 07. May suggest a problem on the Sensor 8 side of Buckstay 11, as changes in Sensor 7 (dark green line) are much less and more gradual. Larger

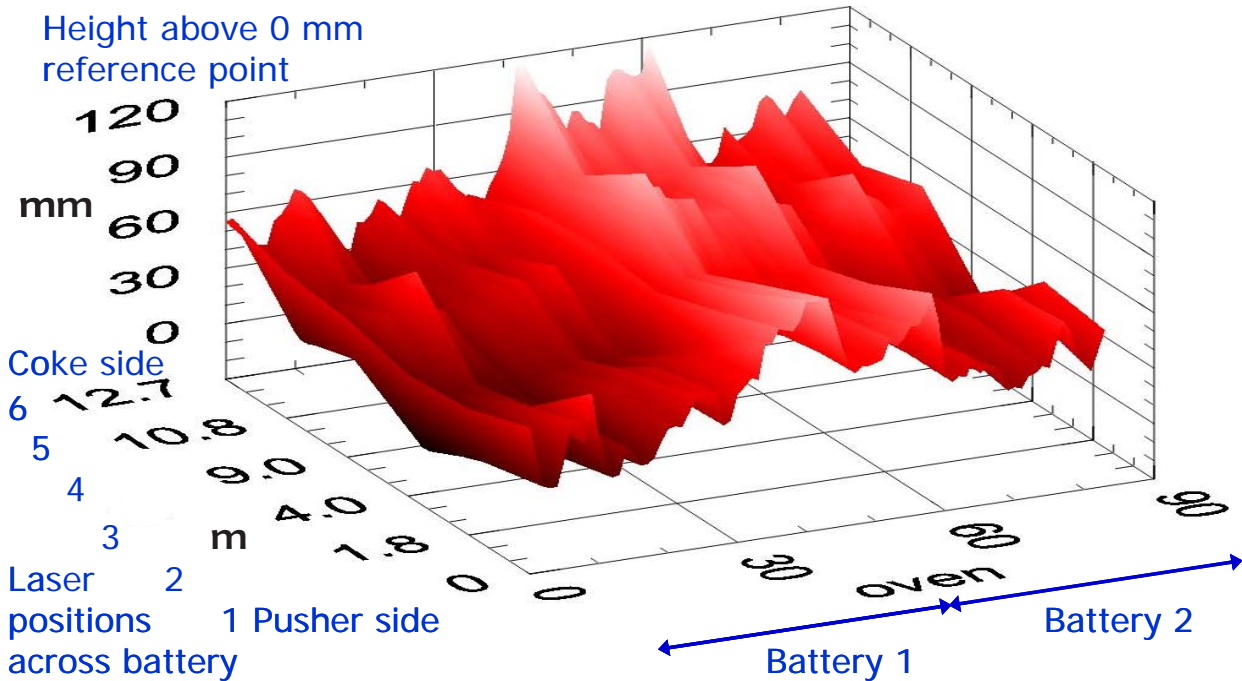
Fig. 31 Surface height variations along and across two batteries

A new system was trialled with Class II laser sensors attached to a moveable beam. A total of five runs were made in two plant trials, when the oven top deflection monitor was pushed along the length of two adjacent batteries. Using the developed software, a series of graphs were obtained showing variations across the oven top and along the length of the batteries. Repeatability of results was good between different runs (as shown in Fig. 24, Task 4.5). Figure 31 illustrates the three-dimensional surface profile map produced from a compilation of the trial data.

Battery top profile monitoring has demonstrated the unevenness of the tops of the two batteries tested (see Fig. 31). Changes in the profile over the next few years will provide early warning of abnormal deviations and opportunity for investigation and repair before critical deterioration of ovens. Battery top emissions and maintenance and repair costs will be reduced. No brickwork movement has been detected around charge hole lids due to roof carbon build-up, but on the surveyed batteries roof carbon tended not to be deposited on the lids.

The oven top deflection monitor permitted full battery top surface profiles to be made. Profiles have demonstrated the unevenness of the tops of the two batteries tested (see Fig. 31). Changes in the profile over the next few years will provide early warning of abnormal deviations and opportunity for investigation and repair before critical deterioration of ovens.

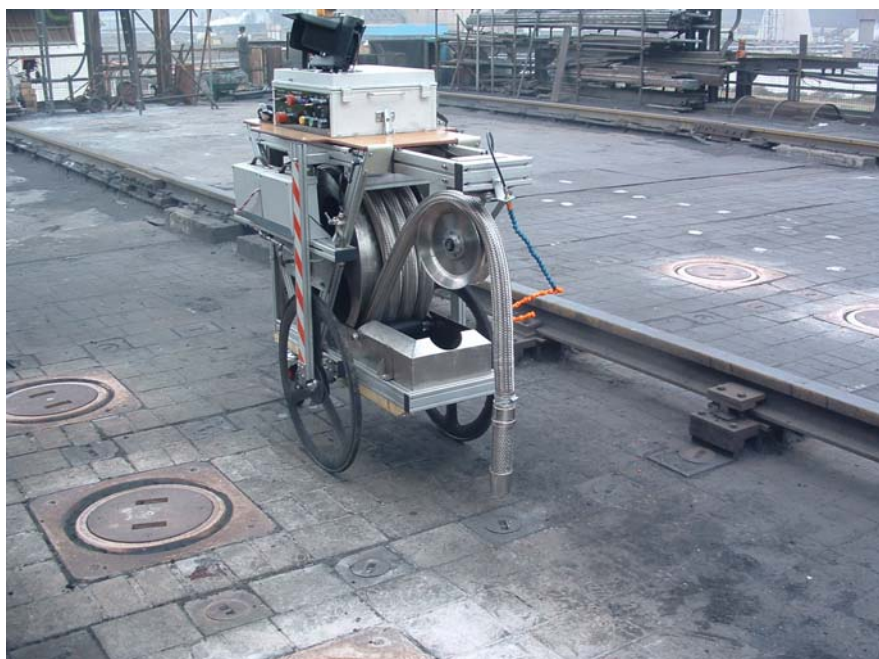
Fig. 32 Automated flue temperature and vision monitor in position on the battery top

Plant trials of the automated flue temperature and vision monitor were carried out to examine a number of flues in the walls of chambers from different parts of two coke oven batteries. Figure 32 shows the insulated, water-cooled measuring head about to be driven down a flue from the mobile trolley. Vertical flue temperature and vision profiles were viewed in real time on the monitor, and stored for comparison with future trial data. Figure 33 illustrates four views taken as the camera descended into a flue in Wall 5. In order to lower the umbilical head into the battery smoothly, the top of each flue was cleaned before monitoring, and small amounts of carbon descended to the bottom of the flue, as shown in Fig 33a (where they burnt up). The upper coke oven gas (COG) and lower blast furnace gas (BFG) burners were clearly visible in the flue. The effectiveness of the insulation and cooling are apparent from the temperatures of the head (15-16°C) and water (13-15°C) recorded on the photographs.

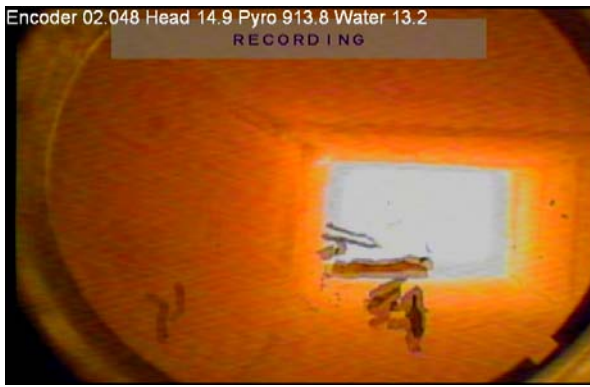
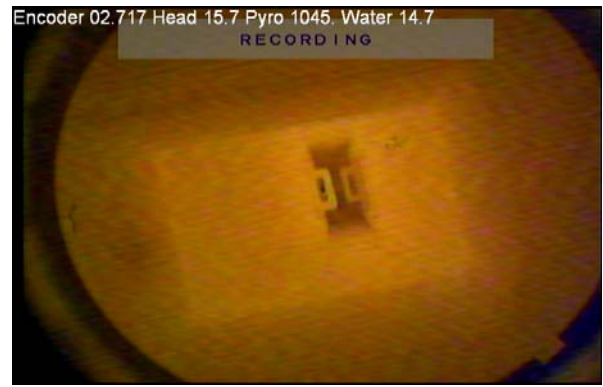
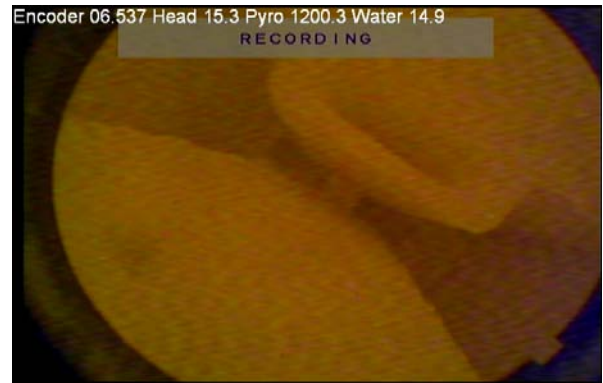
(a) 2 m from battery top showing deposits in flue

(b) 2.7 m from battery top showing 2 burners

(c) 5.2 m from battery top at level of COG burner

(d) 6.5 m from battery top at level of BFG burner

Fig. 33 Photographs from video descending into flue on Wall 55

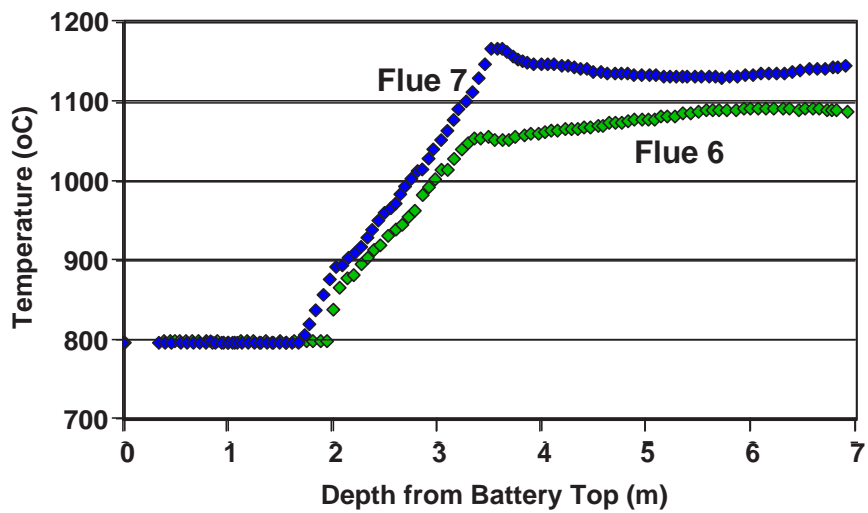
Fig. 34 Thermal profiles of adjacent flues in Wall 44

Figure 34 illustrates the thermal profiles measured in Flues 6 and 7 of Wall 44 where Flue 7 was much hotter than Flue 6. As the pyrometer does not measure below 800°C, changes in temperature are only shown from about 1.8 m below the battery top. Video monitoring was also carried out on these two flues because it was believed that cleaning equipment may have been dropped down Flue 6. However, the video demonstrated that there were no obstructions remaining in Flue 6, but its thermal profile had been affected adversely by previous actions. Further plant investigations are taking place and when repairs have been carried out and heating control has been improved, temperature and vision monitoring of these flues will occur again.

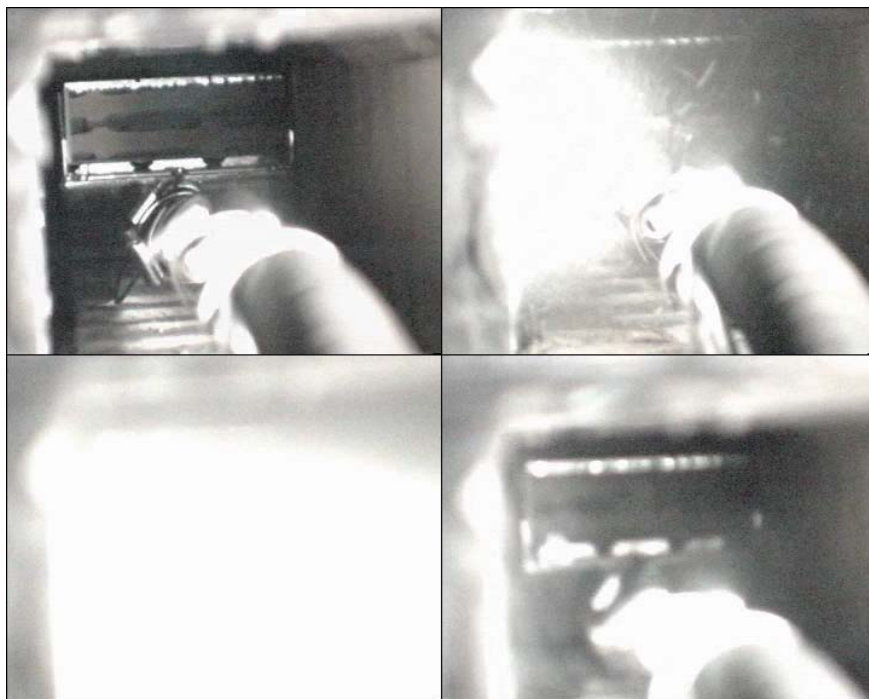
Fig. 37 Photographs of regenerator brickwork inspection with the Prototype 2 inspection/cleaning system

top left	before start of cleaning
top right	start of cleaning
bottom left	during operation of cleaning equipment
bottom right	after operation of cleaning equipment

As shown in Fig. 36, the quality of photographs taken with the improved Prototype 2 inspection system is excellent and much better than with the Prototype 1 inspection system, as long as the added cleaning equipment is not operated during inspection. Photographs shot with the Prototype 2 inspection system before the start, during the start, during operation and after operation of the added cleaning equipment are shown in Fig. 37. It is evident that optical inspection of the regenerator brickwork is disturbed to a great extent during operation of the cleaning equipment by rising dust, which causes too much backscattering of light during cleaning (bottom left photograph).

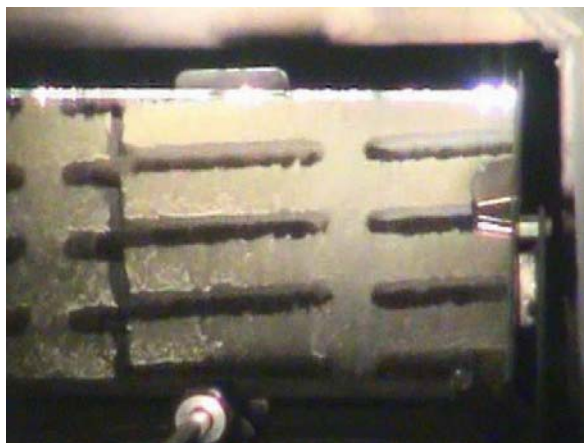
undamaged brickwork

damaged brickwork

Fig. 38 Photographs of regenerator brickwork inspection with the simplified Prototype 3 inspection system

Inspection results obtained with the second prototype inspection system during operation of the cleaning equipment showed that inspection and cleaning have to be separated. For simple inspection without simultaneous cleaning, a simplified third inspection system was developed and tested (with no cooling device and manual adjustment of the swivelling mirror). Photographs shot with the third simplified prototype inspection system are shown in Fig. 38. The quality of photographs taken with the simplified third inspection system is as good as with the more complex second inspection system. Brickwork damage can be identified and made visible with high optical resolution.

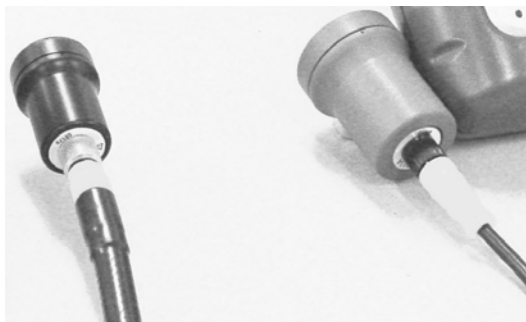
Fig. A1.1 Standard and IR cameras

A major problem in the selection of instrumentation for coke oven applications was heat-resistance, and this increased the length of time required to develop some devices. Corus investigated a number of different types of instrumentation and sensors for flue temperature, tie-bar strain and oven top deflection monitoring equipment. A lightweight, portable video inspection instrument, with a built-in light source for viewing poorly-accessible locations, was selected for flue temperature monitoring. It had a CCD camera designed to function in harsh working environments, constructed from high-impact, heavy-duty plastic to withstand shock and vibration. Figure A1.1 illustrates the standard and infrared cameras available with this system. TFT-LCD technology presented a clear, full video image. As the camera was water-resistant to a depth of 30 m, it could be water-cooled. The display unit had an integral video capture system using a compact flash card, so that images can be stored as single frames or video clips. Figure A1.2 illustrates the ultrasonic sensor selected for initial oven top deflection monitoring tests.

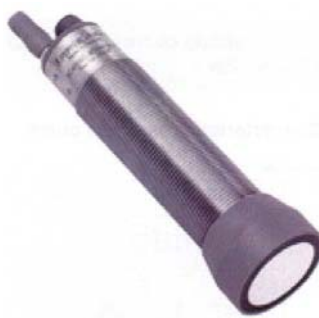
Fig. A1.2 Pepperl+Fuchs ultrasonic sensor

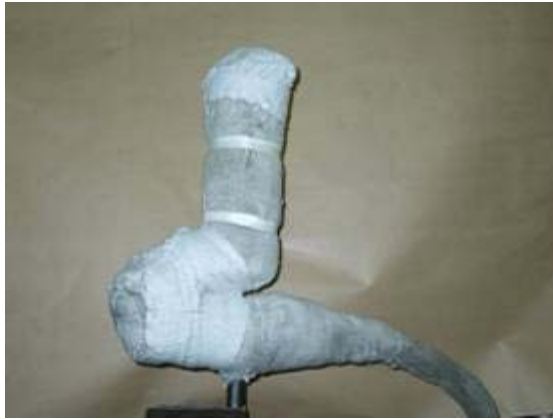
Fig. A1.4 Insulated camera head

In order to test the mechanical and thermal resistance of the camera head as well as the image quality, some tests in industrial ovens were performed at Carling coke plant. For these tests, the camera head was introduced vertically through a charging hole into an empty oven. The camera was connected to the supply sheath and protected with an insulating DELCERAM band. During this trial, the rotating system was ignored. The band was wound up the camera head (see Fig. A1.4) and an opening was made in front of the objective (in Fig. A1.5).

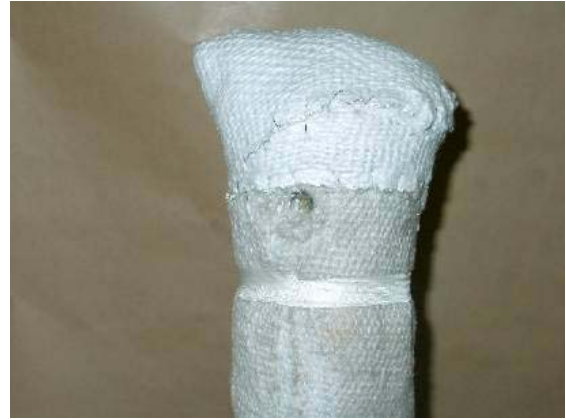
Fig. A1.5 Opening

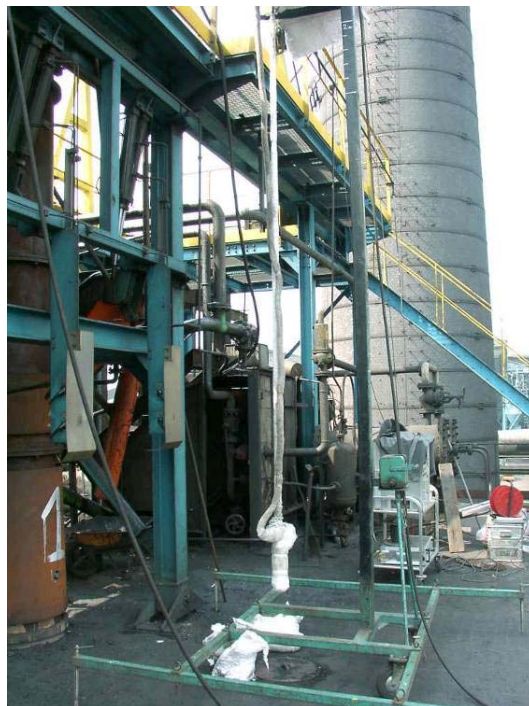
Fig. A1.6 Camera head fixed at the end of a tube before introduction inside an empty oven

The camera head was set at the end of a half inch, 4.5 m long steel tube insulated with a ceramic fibre sheath. The camera supplying sheath was also fixed to the tube and connected to the multiplexing box. The whole device was bound to a jacking-up device (see Fig. A1.6).

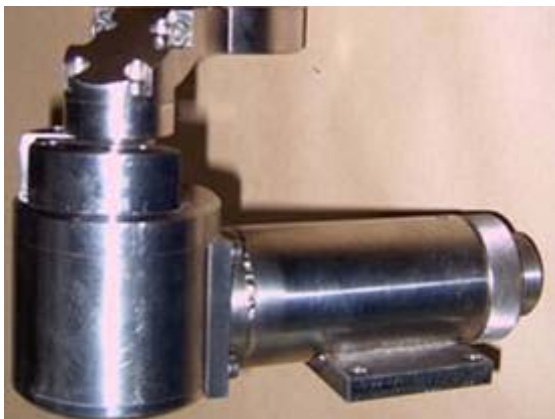
Fig. A1.8 Rotating device

At the start of the first trial, the camera temperature was 32°C. The first images obtained were too dark and the setup of the shutter was observed to be poor. Nevertheless, trials were performed in order to test the insulating material quality and the thermal resistance of the camera. On removal from the oven, the camera temperature was 36°C. After a 10 minute pause (the usual time between two pushing operations), the test was repeated several times (see Fig. A1.7). The trials were stopped after the fourth introduction of the camera, because the image was lost. At this time, the camera temperature was 64°C, but the temperature continued to increase and quickly rose up to 80°C. It was necessary to remove the insulation in order to cool the camera down as quickly as possible, because the insulation was too thick and accumulated too much heat. The 10 minute pauses were not long enough to compensate for the heat transfer to the camera block. Consequently, heat damaged the rotating system, as this mechanical system was covered by a wide stainless steel part (see Fig. A1.8). The metal had become hot and some internal plastic pieces melted (as shown in Fig. A1.9).

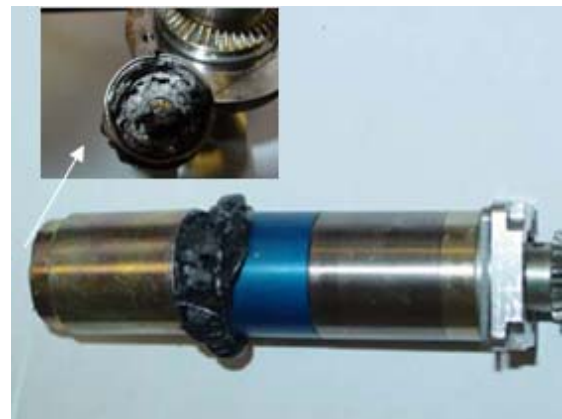
Fig. A1.9 Camera damage

Fortunately, the camera body was made from a fairly thin external metallic tube, and blowing cool air on to it was enough to compensate for the heat transfer between the camera body and the electronics. Nevertheless, after inspection in the CPM workshop, it appeared that an electronic card support was broken. This failure of the card disconnected the camera, which explained the loss of the images during the fourth test.

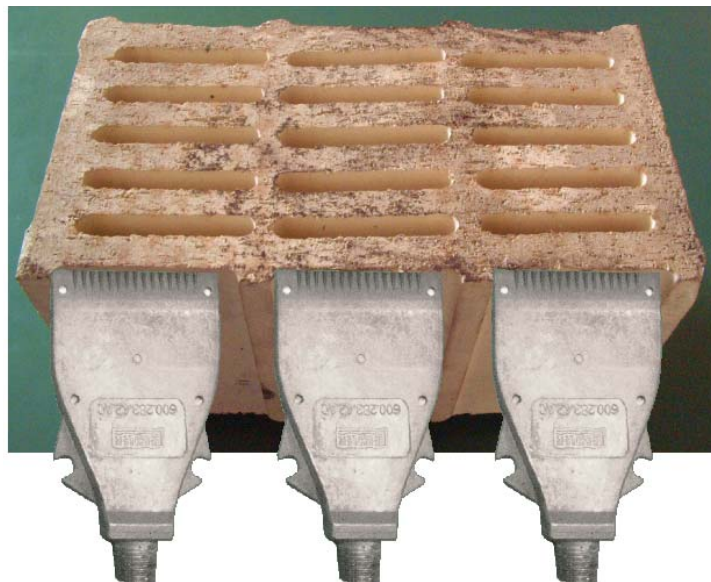
Fig. 1.16 Parallel connection of 3 selected nozzles adapted to the length of checker brick slots

On the basis of the results obtained in the laboratory tests, the nozzle type shown in Fig. A1.15 was selected because the cleaning system can be adapted very well to the length of the checker brick slots with this nozzle type, for example three nozzles connected in parallel (Fig. 1.16). The blowing force of the selected nozzle, which is lower than the blowing force of other tested nozzles, can be enforced by a raised air pressure.

A regenerator cleaning equipment with 3 air nozzles was developed to blow away dust and other deposits from the regenerator brickwork by use of pressurised air. A nozzle type was used that had been selected by laboratory testing in WP1/Task 1.2 (Figs. A1.15-A1.16). Pressurised air was not only used for cleaning, but also for cooling purposes with a common air supply. The cleaning equipment was combined later with an improved Prototype 2 inspection system in Task 3.3. Photographs of the combined inspection/cleaning system are shown in Fig. A3.4. Operation of the cleaning equipment in the Prototype 2 inspection/cleaning system was tested successfully in plant trials at a German coke plant regenerator in WP 6. With it, large quantities of dust and other deposits could be removed from the lower sections of the regenerator brickwork.

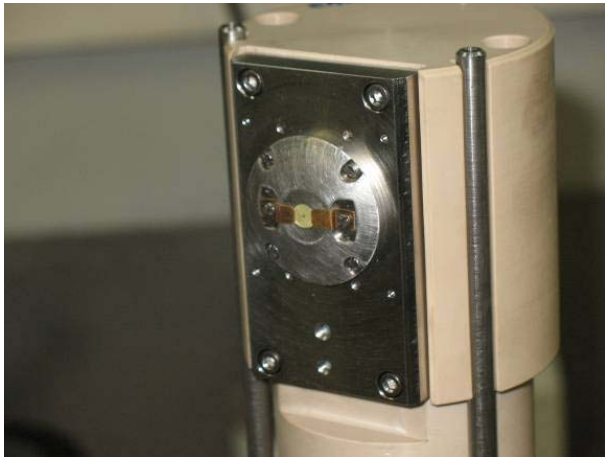
Fig. A2.1 Camera head without stainless part

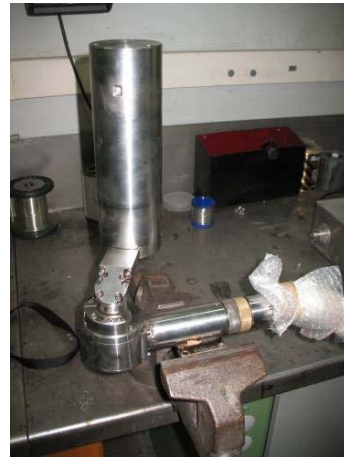
Fig. A2.2 Camera head without insulation

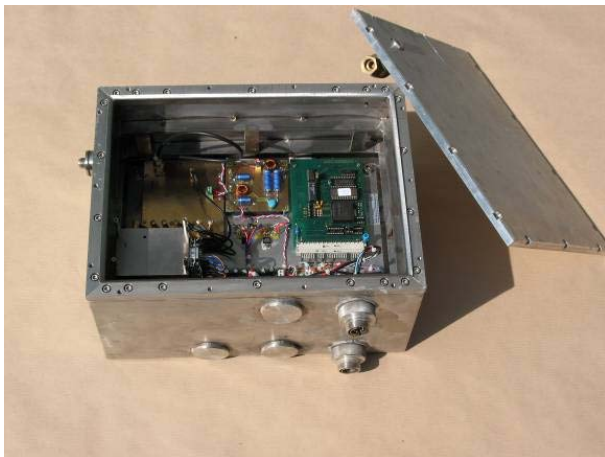
Fig. A2.3 Multiplexing box

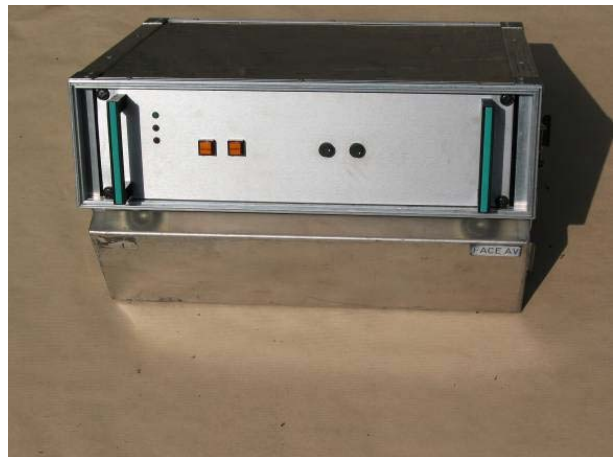
Fig. A2.4 Demultiplexing box

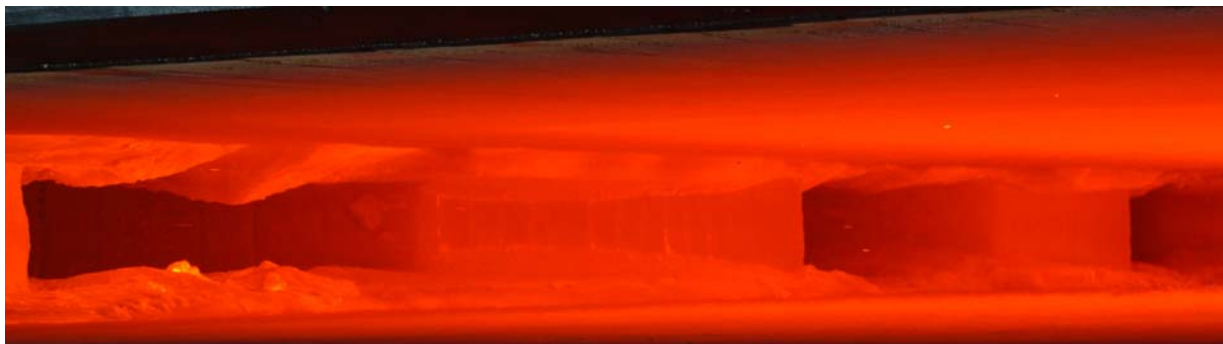
Fig. A2.5 Roof carbon in situ

Samples of roof and wall carbon deposits were obtained from five different Corus batteries (see Task 5.1), and supplied to UNOTT. Figure A2.5 shows the appearance of a carbon deposit in a Battery 3 oven, and Figs. A2.6 and A2.7 illustrate some of the textures in roof and wall deposits from Batteries 1 and 2.

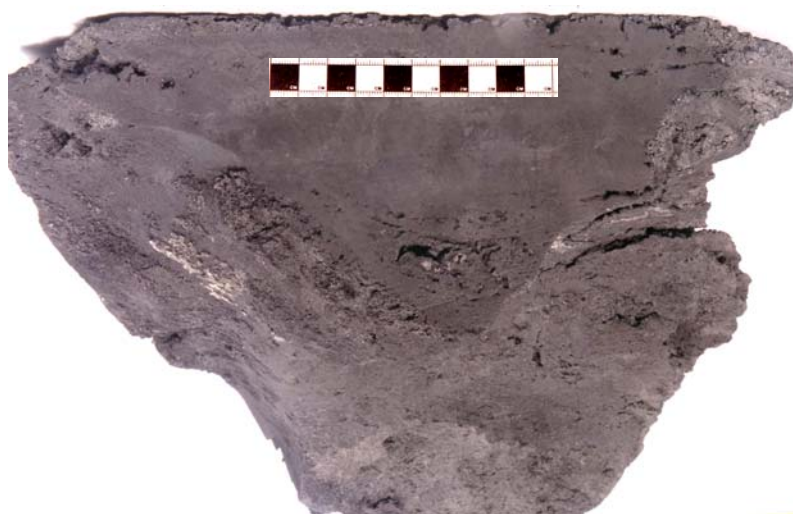
Fig. A2.6 Layering in Sample A roof carbon deposit parallel to the oven wall

(scale bars are 1 cm)

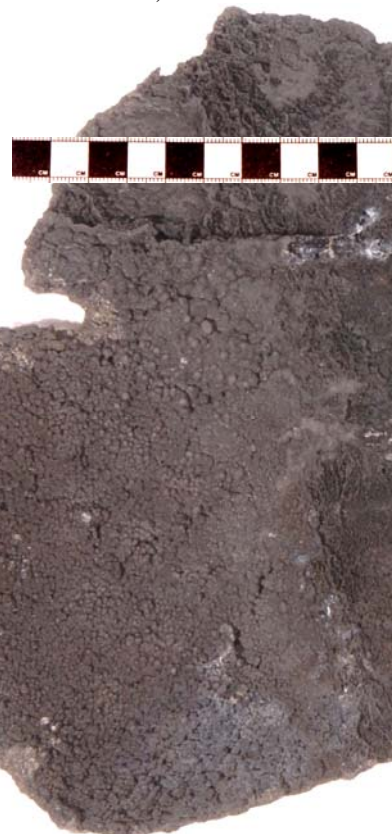
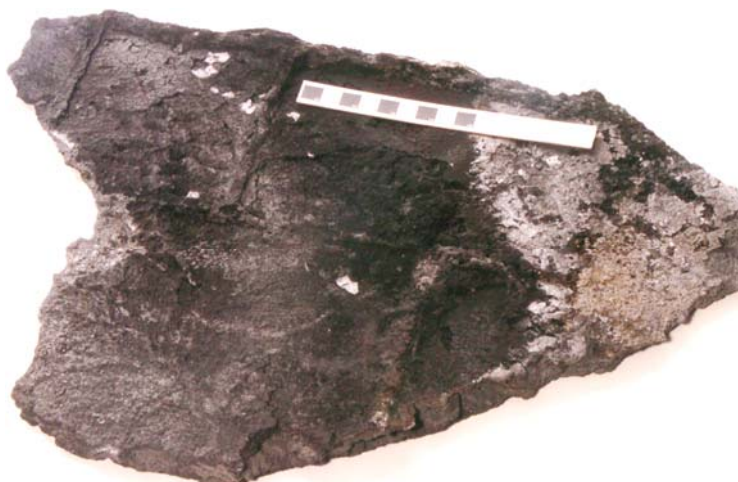
Fig. A2.7 Wall carbon deposits - L: brick pattern from wall, N: globular laminar carbon on coke-side

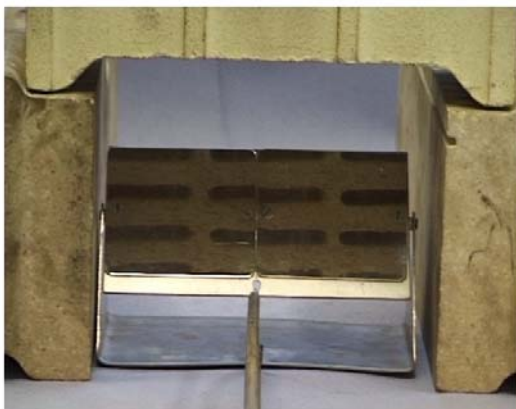
Fig. A3.2 Camcorder view of the swivelling mirror of Prototype 1 inspection system at a cold test checker brick

A photograph of the Prototype 1 inspection system is shown in Fig. A3.1. Preliminary tests were conducted with this system in the laboratory on a single cold checker brick. Figure A3.2 shows the swivelling mirror at an angle of 45° underneath the cold checker brick. While the camcorder looks perpendicularly at the mirror, the dark slots of the checker brick for distribution of hot flue gas and combustion air can be seen.

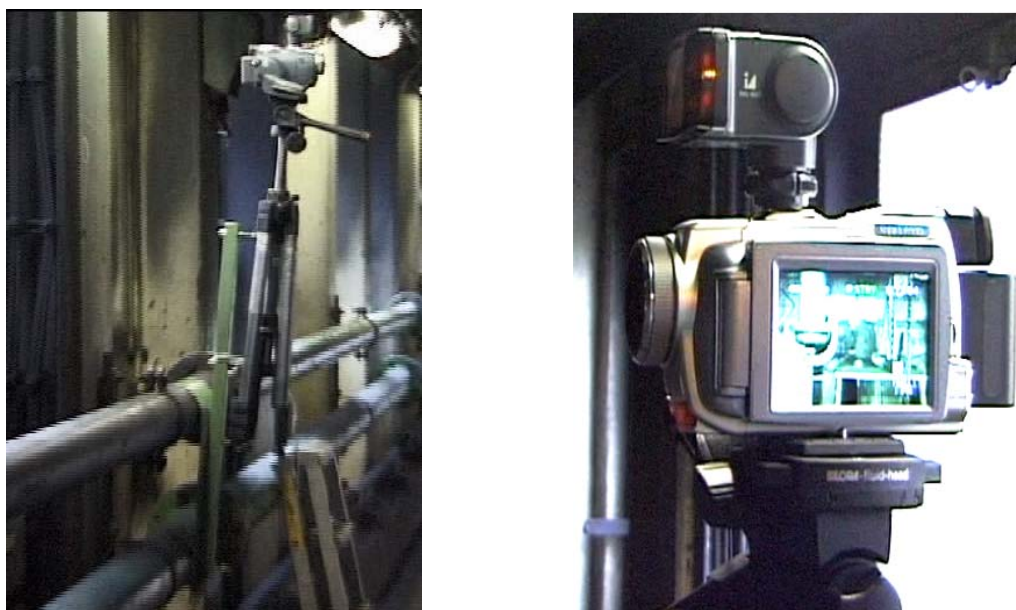
Fig. A3.6 New camcorder with additional illumination

A sketch of the optimised Prototype 2 inspection system was shown in Fig. A3.5, and photographs of it with the new camcorder are illustrated in Fig. A3.6. The Prototype 2 inspection system was tested in plant trials at a regenerator of a German coke plant within WP 6 without and with simultaneous operation of the cleaning equipment. When inspection was run without simultaneous operation of the cleaning equipment, results from the plant trials showed that conditions of lower brickwork sections of the regenerator can be monitored and analysed in detail very well with this system. However problems

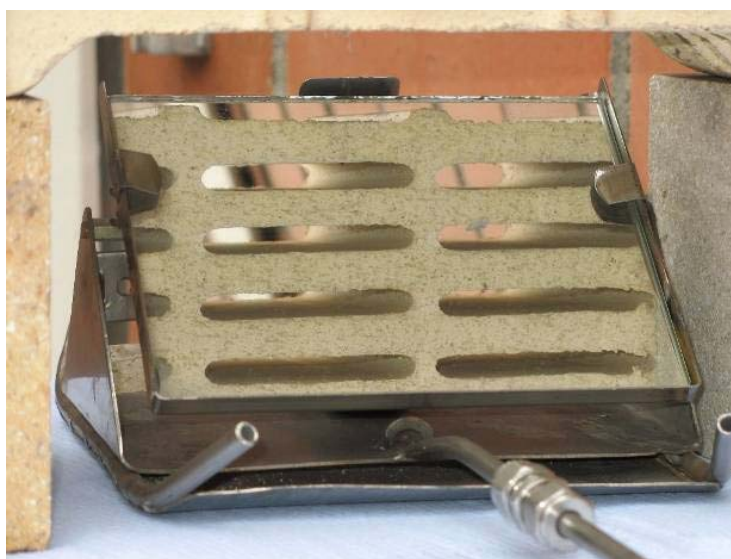
Fig. A3.7 Simplified Prototype 3 inspection system

Due to the findings in the WP6 plant trials showing that simultaneous optical inspection and cleaning of the regenerator brickwork is not possible and taking into account the operational problems of the Prototype 2 inspection system in deeper sections of the regenerator sole flue, a much simplified Prototype 3 inspection system without any cleaning and cooling device was developed. This prototype (shown in Figs. 10 and A3.7) is based on a moveable mirror/slide-system, in which the mirror has to be adjusted manually before start of inspection. Tests at a regenerator of a German coke plant (conducted in WP 6) showed that the simplified Prototype 3 inspection system can be applied successfully without any heat protection and cooling in the regenerator sole flue at temperatures in the range of 240-290°C.

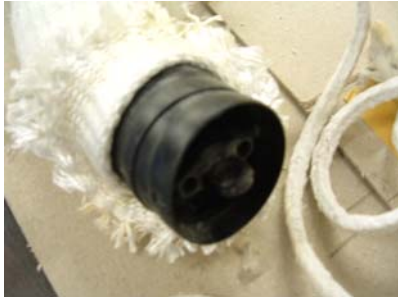
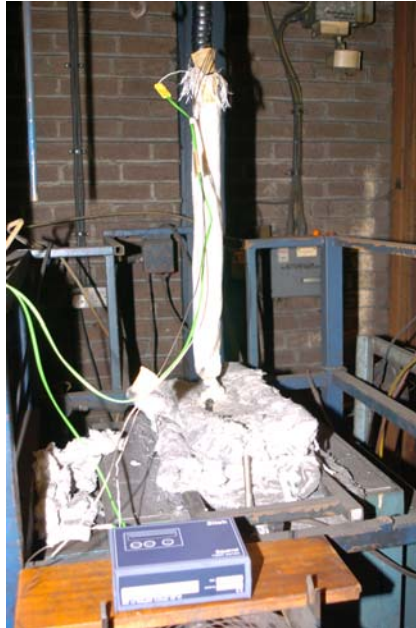
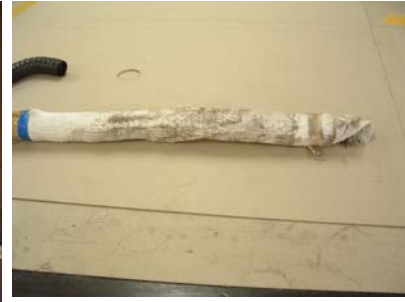
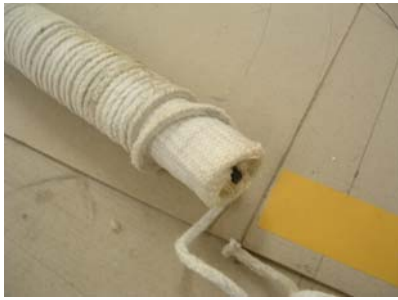
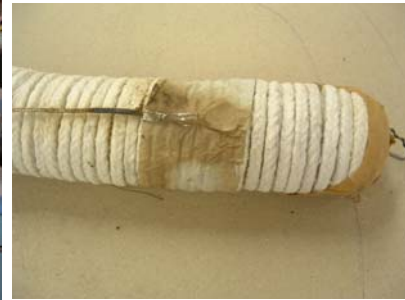
Fig. A3.9 Insulation of conduit

Fig. A3.10 Test piece about to be inserted into the furnace

Fig. A3.11 After test, insulation shows no adverse effects

Figures A3.9-A3.11 show tests carried out on the system. The conduit was wrapped in a flexible insulating tube, around which ceramic rope was spiralled in Fig. A3.9, and a further flexible insulating tube was applied over these layers. Embedded within the layers were thermocouples to monitor the temperature rise during the tests. Prior to insertion into the furnace, the insulation was immersed in water until the whole test piece was saturated, and then the excess water was allowed to drain off for 30 minutes. The furnace temperature was maintained at 1200°C and the test piece was inserted for 30 seconds (see Fig. A3.10), after which it was removed and allowed to cool naturally. Its core temperature was monitored throughout the heating cycle and after removal from the furnace. After the trials, the test piece was dismantled and checked for the effects of heat on the core. Figure A3.11 demonstrates that there were no adverse effects to the insulation layers from the heating test, and even the plastic core covering remained in tact. In Fig. A3.12, the heating/cooling curve of one of the tests indicates that the core did not rise above 70°C.

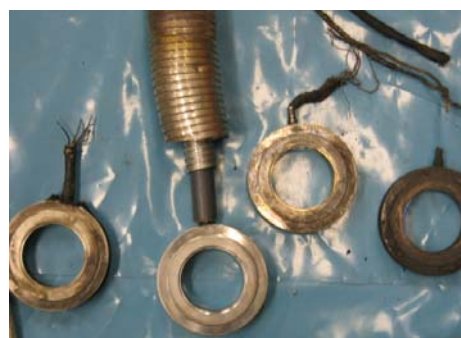
Fig. A3.16 Three damaged cables and load washers and improved one in centre

Plant trials began with the load cells fitted to a pair of tie-bars on one buckstay, but there were problems with cables burning (see Fig. A3.16). A test facility was used to determine the effectiveness of various types of insulation for the cables. Flame tests were carried out in the laboratory with a range of heat-resistant materials, including silicone/fibre composites, combined with temperature-resistant cable capable of operating at temperatures in excess of 200°C for short periods of time. Figure A3.17 shows graphs from tests of two different sheathing materials, with two thermocouples demonstrating the difference in temperature between the outer and inner surfaces. The outer surface (pink line) was maintained at >1000°C for around six minutes by a butane flame, and the temperature of the inner core (blue line) was monitored. With the first material the core temperature reached 125°C, but the second material was more insulating with a maximum temperature around 80°C. Load cells were constructed

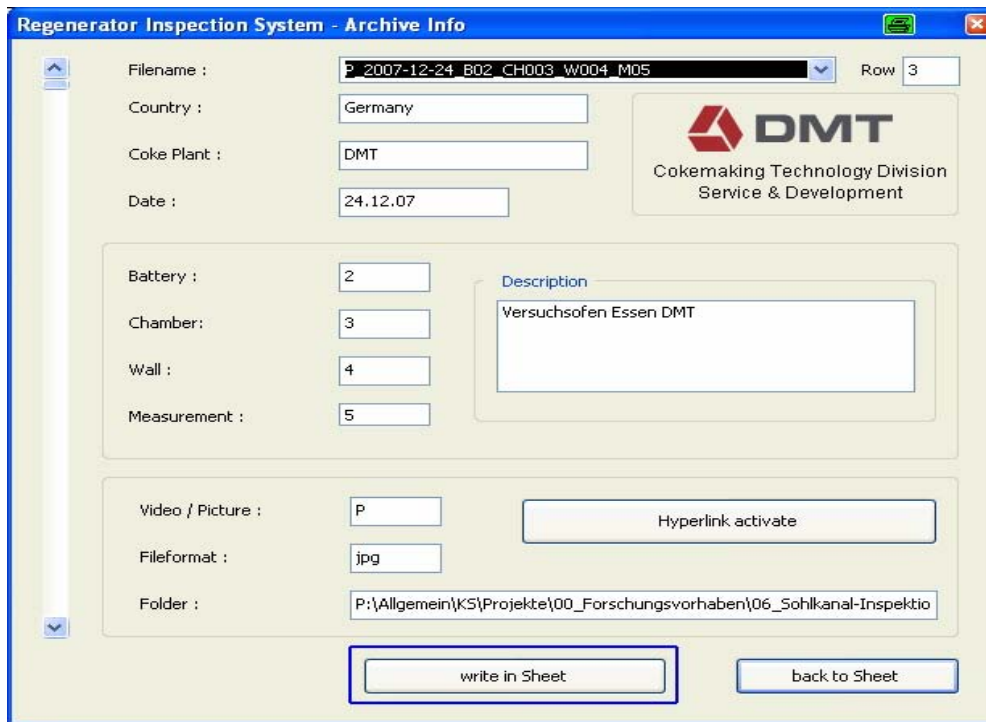
Fig. A4.11 Input data mask of RISA

For the organisation and archiving of the data files obtained from video recording, basic software from ULEAD Systems was used to develop and optimise RISA (Regenerator Inspection System Archive). Functions for input data and search functions were implemented additionally by DMT into RISA on the basis of EXCEL. The input data mask and a screenshot of RISA are shown in Figs. A4.11 and A4.12.

- general information (filename, country, coke plant, date)
- location of inspection (battery no., chamber no., wall no., measurement no.)
- file details (file format, location of data storage, video/photograph)

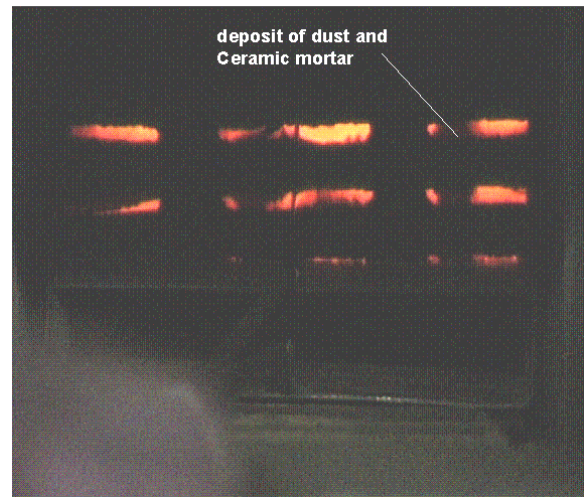
Fig. A6.21 Photographs of regenerator brickwork inspection with the Prototype 1 inspection system

Figure A6.21 showed photographs taken from the inspection of the sole flue of the coke plant at the heating flue No. 28 with the Prototype 1 inspection system, in which the position and swivelling angle of the welding mirror was adapted and controlled manually. The two photographs were shot with a standard camcorder from different positions on the movable slide and with different inclinations of the swivelling mirror. In spite of darkness, from a total of 15 slots of the single brick, 6-8 slots were made visible by light incidence from temperature radiation in upper parts of the regenerator brickwork. Small tears/breaks and deposits of dust and ceramic mortar can be identified roughly, but they were not made clearly visible with a satisfactory optical resolution. The selected welding mirror showed good resistance to thermal stresses, but only mediocre optical properties. Enhanced lighting was needed for the camcorder.

In plant trials, the Prototype 1 inspection system showed insufficient optical properties. Brickwork damage could only be identified very roughly, as details were only just visible with low optical resolution. The improved Prototype 2 inspection/cleaning system provided excellent inspection photographs, when the added cleaning equipment was not operated during inspection. Good cleaning results were achieved with the added air nozzle cleaning equipment in lower sections of the regenerator brickwork. However during cleaning, optical inspection was disturbed by swirling dust. With the simplified Prototype 3 inspection system without any cleaning equipment, photographs were obtained with the same high quality and optical resolution as with the more complex Prototype 2 inspection system.
