IMPECABL: Improving environmental control and battery life through integrated monitoring systems

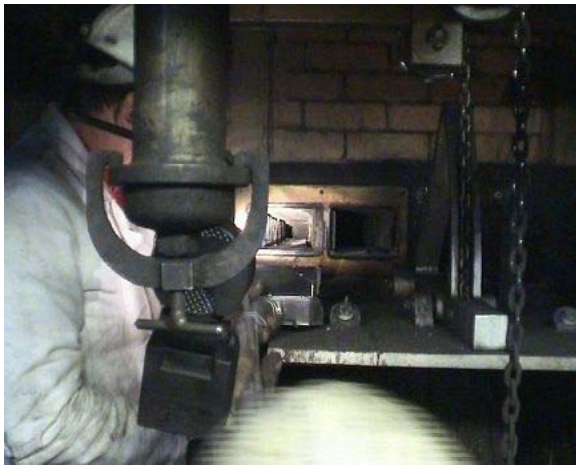
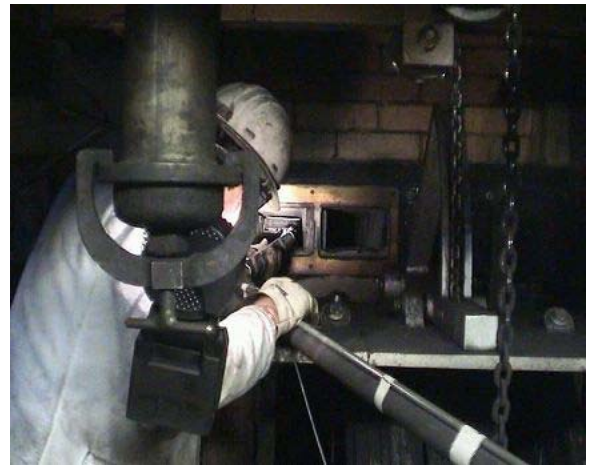
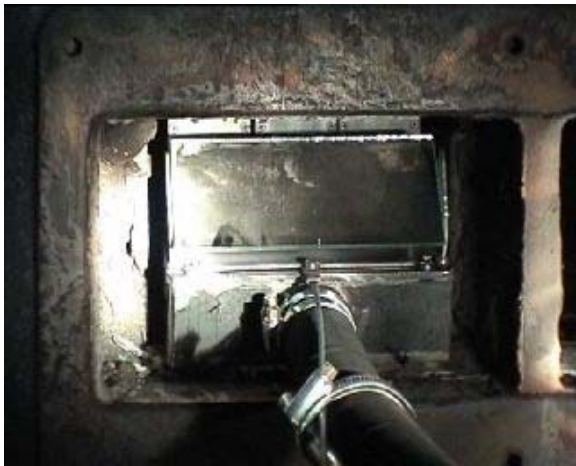
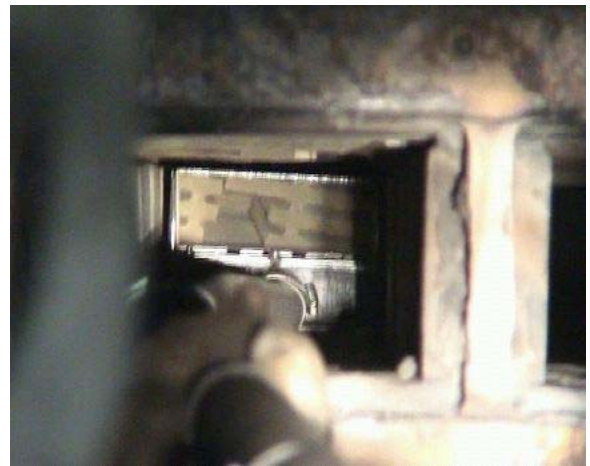
Fig. A6.22 Insertion of the Prototype 2 inspection/cleaning system into the sole flue

Insertion of the Prototype 2 inspection/cleaning system into the sole flue of the coke plant is shown in the photographs of Fig. A6.22. First inspection tests were conducted without simultaneous operation of the cleaning equipment. With the radio-controlled swivelling mirror, a fast and targeted scan of the lower brickwork sections could be obtained. Photographs shot during these inspection tests are shown in Fig. A6.23 (visual mode of the camcorder) and Fig. A6.24 (IR-mode of the camcorder).

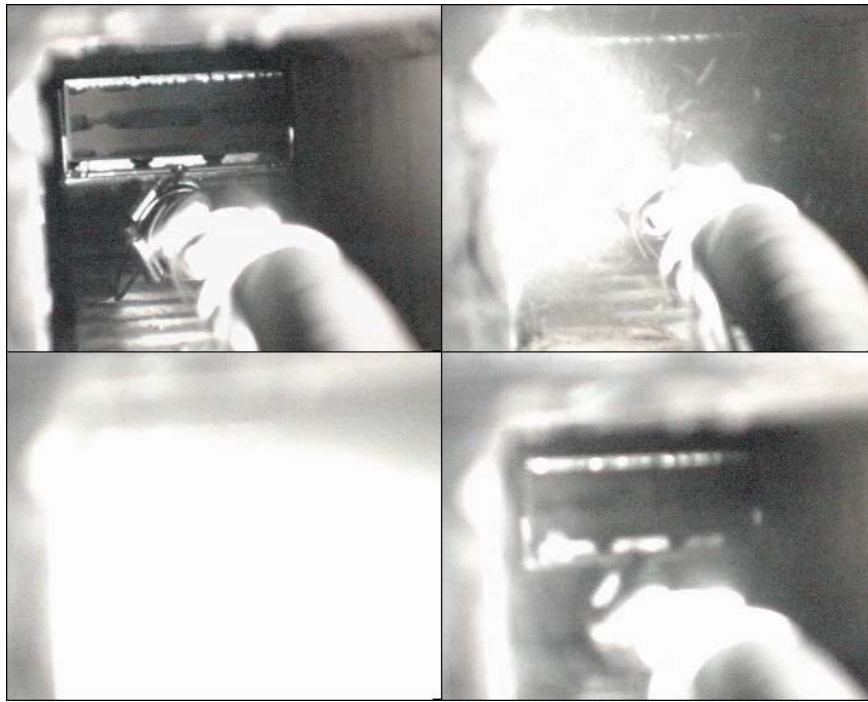
Fig. A6.25 Photos of regenerator brickwork inspection with the Prototype 2 inspection/cleaning system with simultaneous operation of the cleaning equipment
left top before start of cleaning
right top start of cleaning
left bottom during cleaning
right bottom after cleaning

Additional inspection tests were conducted with simultaneous operation of the cleaning equipment. By running the air nozzle cleaning equipment, large quantities of dust and other deposits could be blown away from the brickwork in lower sections of the regenerator brickwork, so that good cleaning results could be achieved in these sections of the regenerator. Because the swirled dust particles are deposited again lower down in deeper sections of the sole flue, an aspiration may be necessary after some cleaning procedures. Whether cleaning effects could also be achieved in upper brickwork sections of the regenerator with the air nozzle cleaning equipment could not be evaluated exactly. However, improved cleaning with the nozzle system can be expected for these regenerator sections also, compared to the conventional method of blowing undirected compressed air into the sole flue. Photographs shot with the Prototype 2 inspection system in trials with simultaneous operation of the added cleaning equipment are shown in Fig. A6.25, before start of cleaning, at start of cleaning, during and after operation of the added cleaning equipment. From Fig. A6.25, it becomes evident that optical inspection of the regenerator brickwork is disturbed to a large extent during operation of the cleaning equipment by swirling dust, which causes backscattering of light during cleaning. Consequently, any optical recording is impossible during cleaning. For that reason, optical inspection and cleaning have to be run separately.

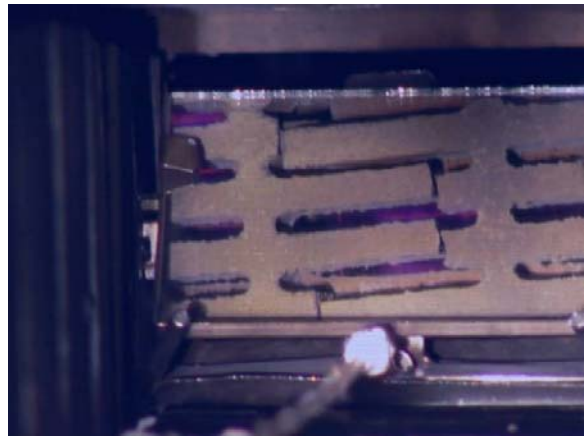
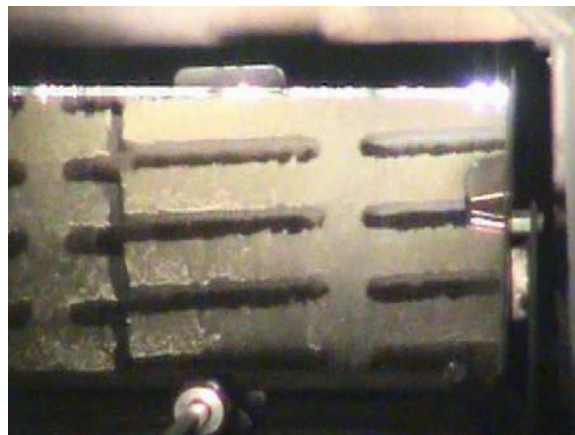
Fig. A6.26 Photographs of regenerator brickwork inspection with the simplified Prototype 3 inspection system

undamaged brickwork

damaged brickwork – cracks

damaged brickwork – displacement

damaged brickwork – deposits of soot

damaged brickwork – structural surface damages

In plant trials, the Prototype 1 inspection system showed insufficient optical properties. Brickwork damage could only be identified very roughly, as details were only just visible with low optical resolution. The improved Prototype 2 inspection/cleaning system provided excellent inspection photographs, when the added cleaning equipment was not operated during inspection. Good cleaning results were achieved with the added air nozzle cleaning equipment in lower sections of the regenerator brickwork. However during cleaning, optical inspection was disturbed by swirling dust. With the simplified Prototype 3 inspection system without any cleaning equipment, photographs were obtained with the same high quality and optical resolution as with the more complex Prototype 2 inspection system.

In plant trials with the newly-developed swivelling mirror/camera inspection system, some regenerator brickwork damage could be detected in the sole flue of a German coke plant. Besides deposits of soot and dust, cracks and breaks could be monitored in some parts of the regenerator brickwork. Over time, slight and medium damage of the regenerator brickwork cannot be avoided, even with best maintenance and smooth coke plant operation. Slight and medium brickwork damage often occurs due to normal thermal stresses, whereas severe damage is caused mostly by uneven heating and local overheating over long periods, which results in various problems for operators of coke plants.
